WT-1631

(6) DAMAGE *to* EXISTING EPG STRUCTURES (U) *(U)*

This report presents the final results of one of the projects participating in the military-effects programs of Operation Hardtack. Overall information about this and the other military-effects projects can be obtained from ITR-1660, the "Summary Report of the Commander, Task Unit 3." This technical summary includes: (1) tables listing each detonation with its yield, type, environment, meteorological conditions, etc.; (2) maps showing shot locations; (3) discussion of results by programs; (4) summaries of objectives, procedures, results, etc., for all projects; and (5) a listing of project reports for the military-effects programs.

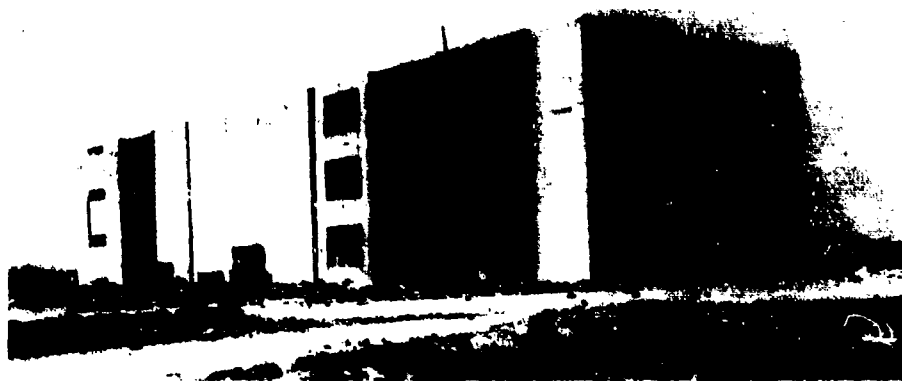
be made. An overall, pre-Hardtack view of this station is shown in Figure 4.35. A preshot view of typical damage to a first floor column (Col. 13C) in Building 5 is shown in Figure 4.36. Building 5, a reinforced-concrete structure with window openings, received more damage from previous operations than any other of the buildings. The other noticeable damage from previous

Figure 4.35 Preshot, (Item 26) Station 3.1.1, Site Janet.

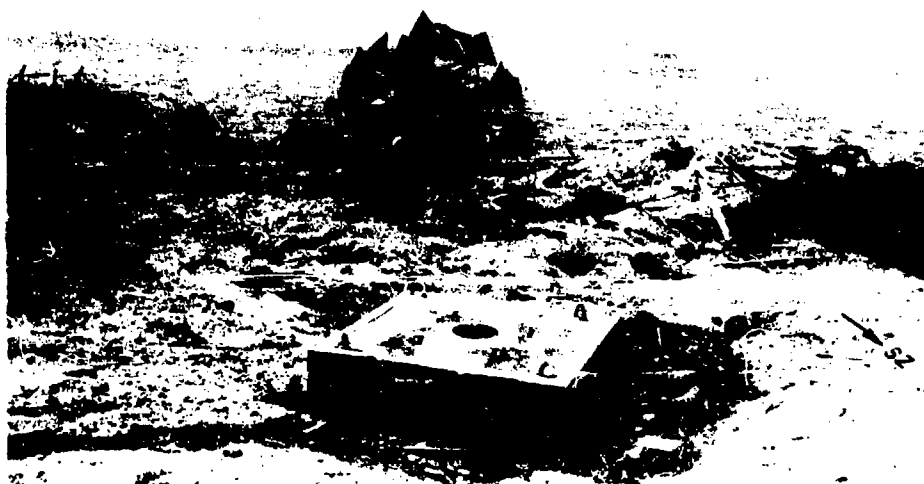
Figure 4.102 Post-Butternut, radar reflector. Pressure level: Butternut, 5.8 psi.

Radar Reflector. A multiunit, radar reflector, undamaged from the effects of Shot Cactus, was ripped from its concrete foundation and thrown 50 feet from the effects of Shot Butternut. A view of this station, which was located in the estimated 5.8-psi range from Shot Butternut, is shown in Figure 4.102.

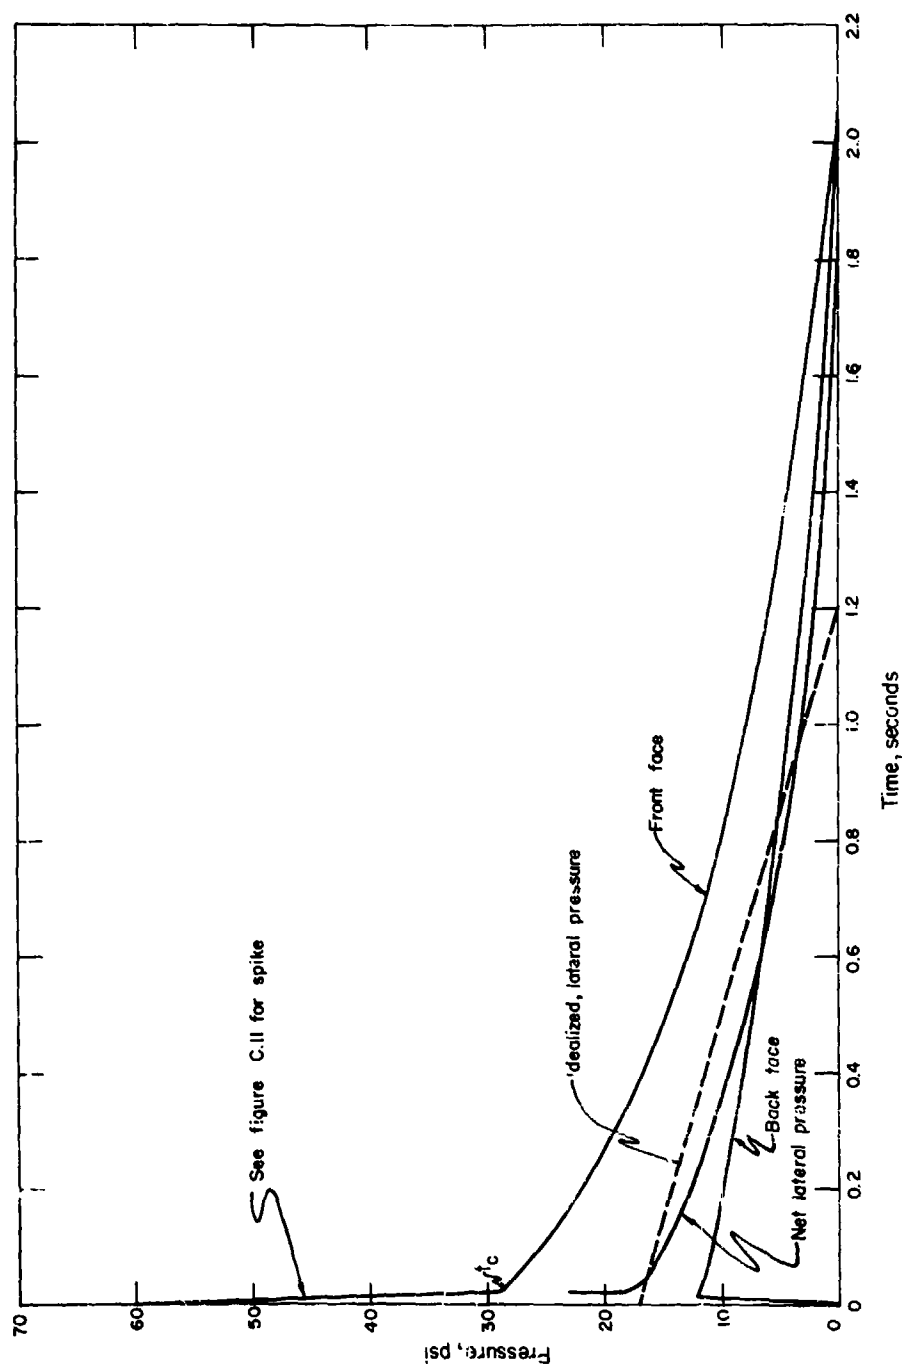
Figure C.9 Effective blast pressure on Station 20-D.

The pressure of 17 psi was sufficient to cause failure of the beam.
